Mini 'magic' MRI scanner could diagnose footballer knee injuries more accurately

June 28 2019

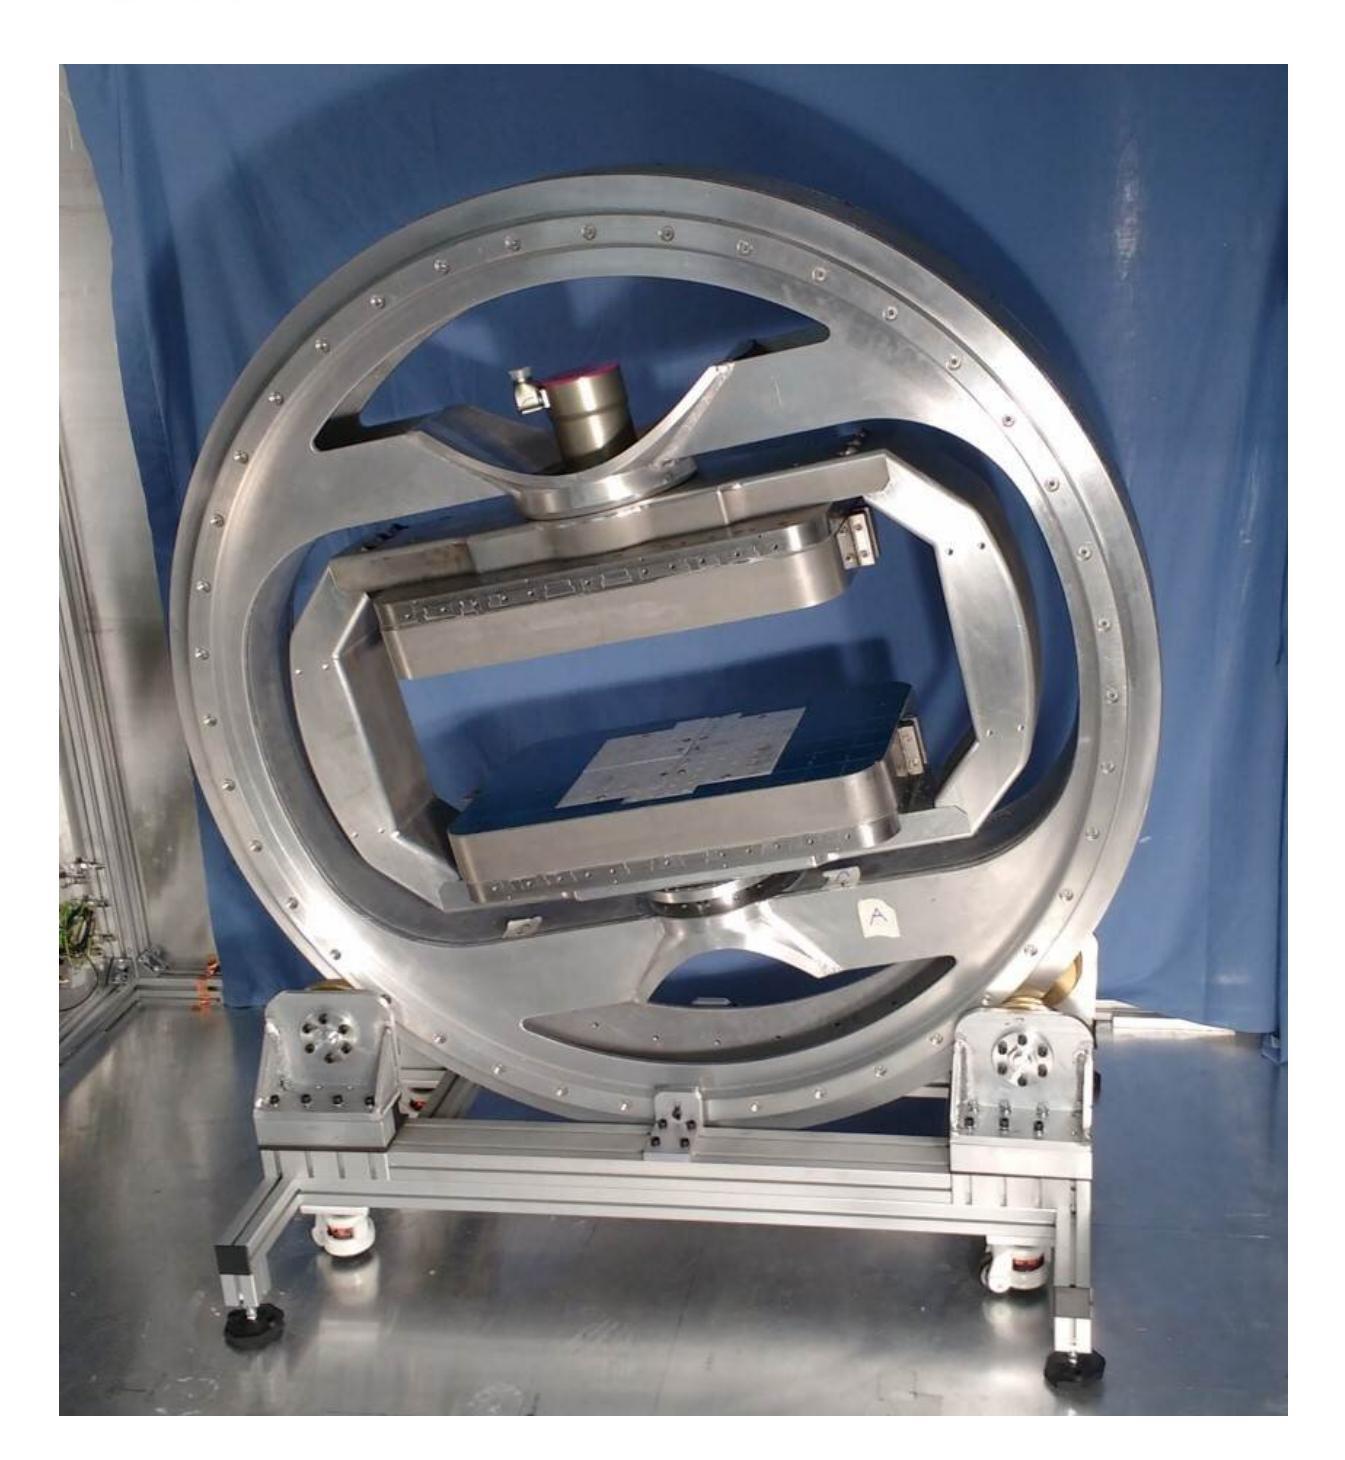
A prototype 'mini' MRI scanner, developed by Imperial College London, that could be used for diagnosing knee injuries. Credit: Imperial College London

The scientists say the device (which looks like a large metal ring through which a patient places their leg) could help diagnose conditions such as anterior cruciate ligament injuries—particularly common among footballers.

The team explain the magic angle is achieved in their scanner because they are able to easily change the orientation of the magnetic field. While the patient sits comfortably in a chair, the specially designed magnet (which uses motors and sensors similar to those found in robots in car factories) can rotate around the leg and the orientate magnetic field in multiple directions.

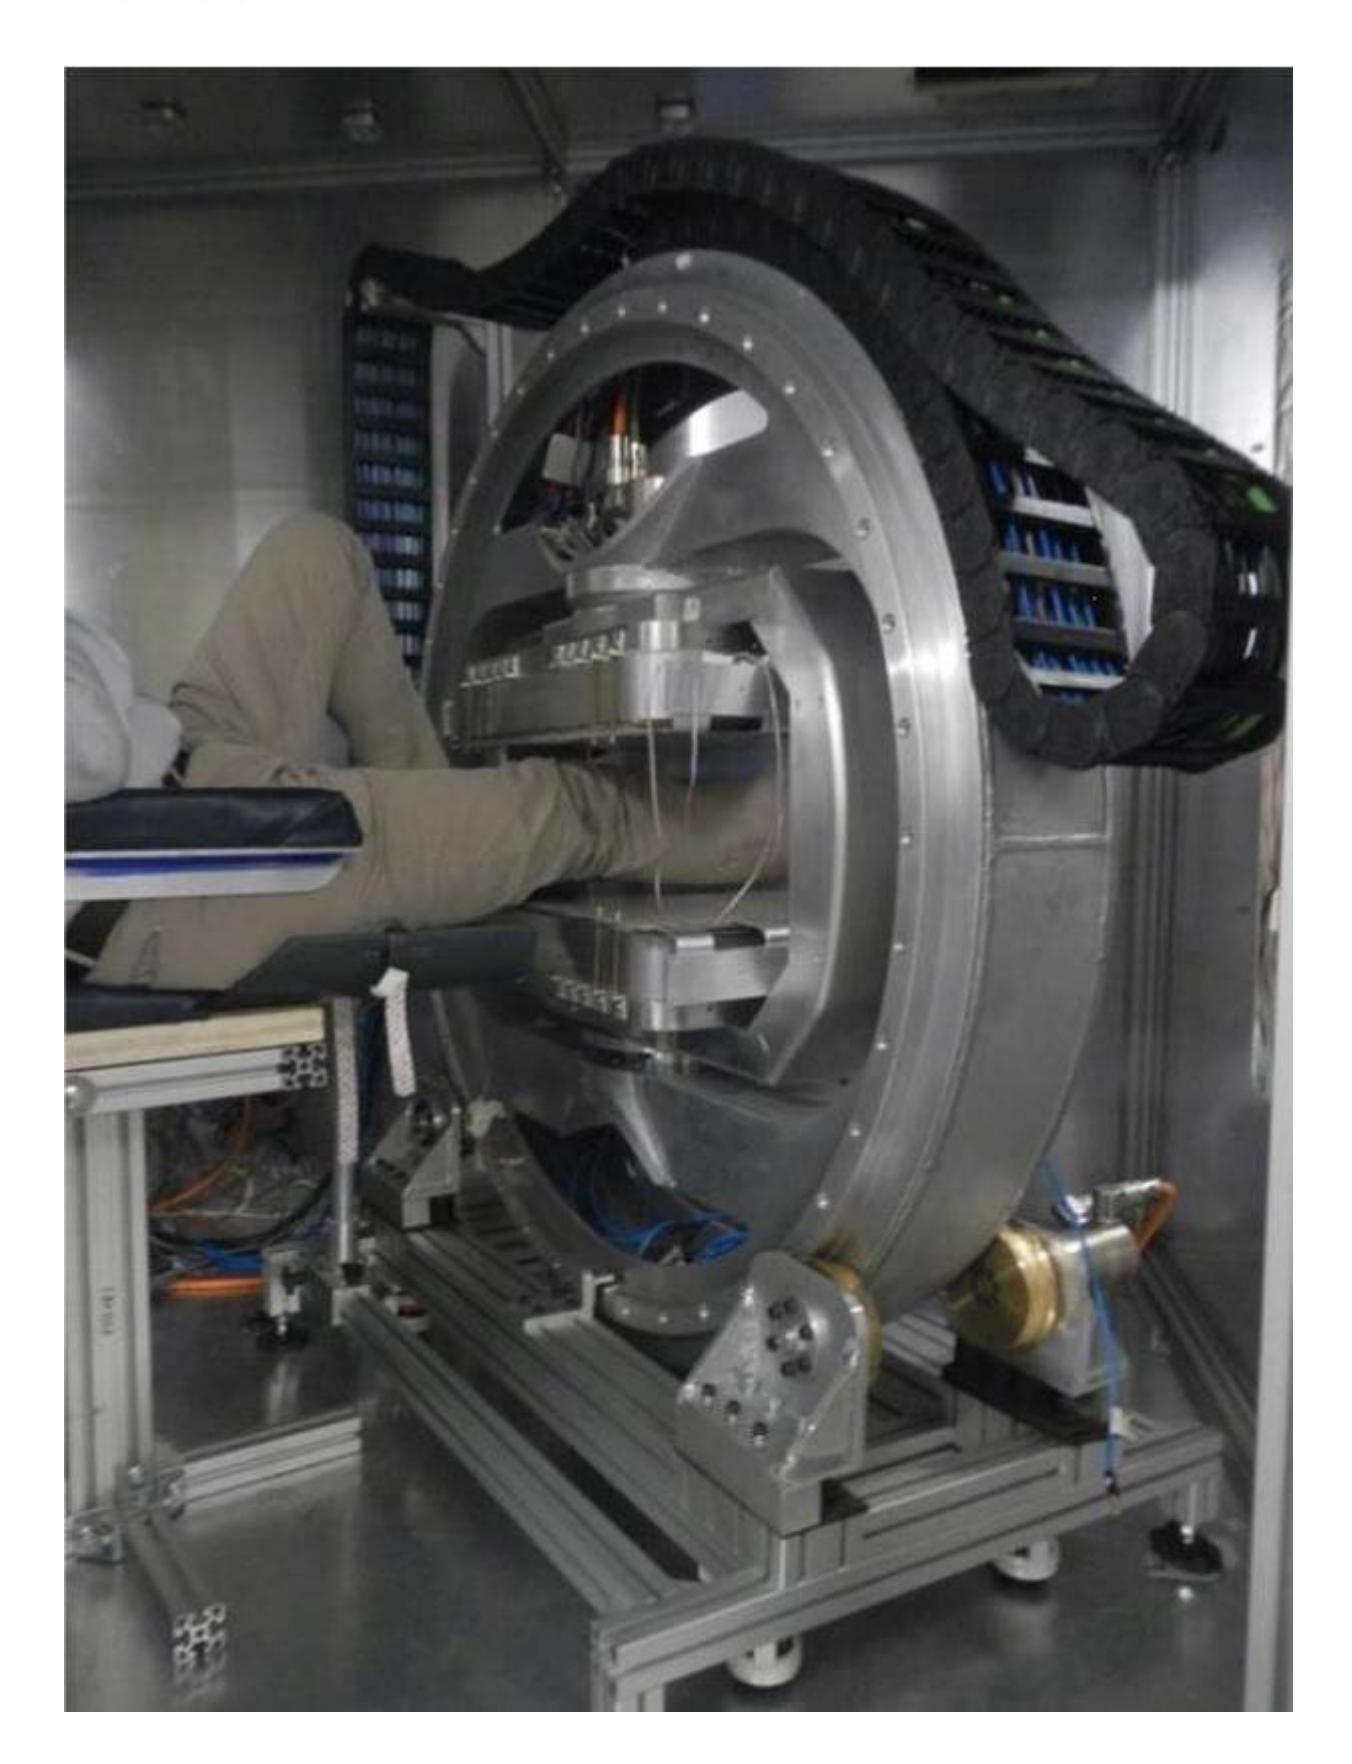
A prototype 'mini' MRI scanner, developed by Imperial College London, that could be used for diagnosing knee injuries. Credit: Imperial College London
