## Lung injuries from vaping have characteristic patterns on CT

August 27 2020

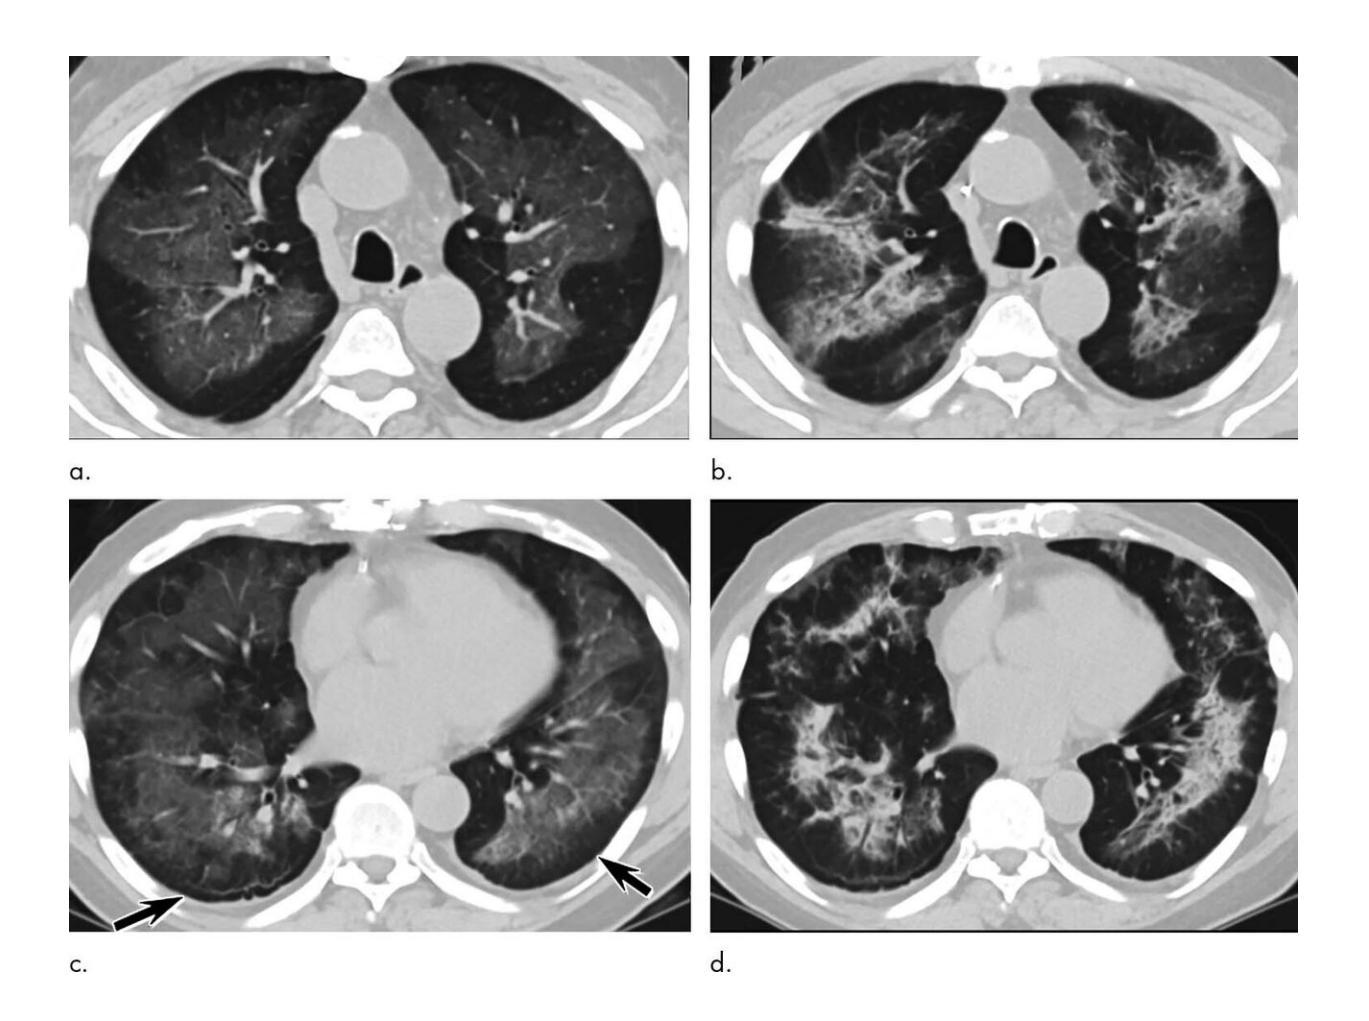
Electronic cigarette or vaping product use-associated lung injury in a 51-year-old man manifesting as an acute lung injury pattern at CT with subsequent organization. (a, c) Axial unenhanced CT images at presentation through (a) mid and (c) lower lungs show ground-glass opacity with subpleural sparing (arrows); this distribution was present in 45% of chest CT studies at presentation in our cohort (11). (b, d) Axial unenhanced CT images obtained 6 days later show

ground-glass opacity has transitioned to consolidation and mild architectural distortion, consistent with developing organization. The patient was initially treated with antibiotics followed by corticosteroid therapy, with slow clinical improvement. Credit: Radiological Society of North America

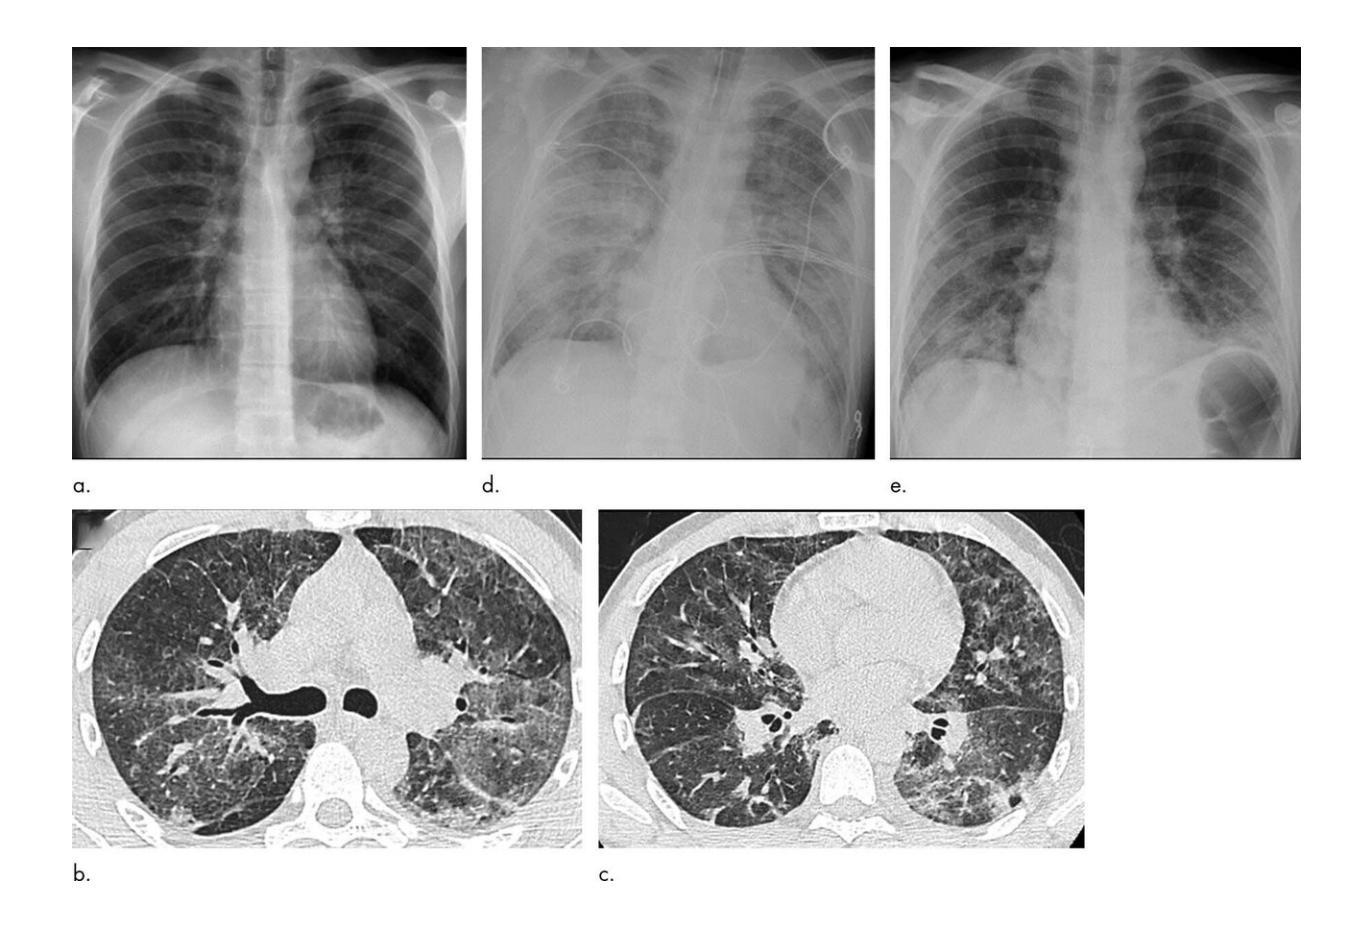
Electronic cigarette or vaping product use-associated lung injury in a 27-year-old man manifesting as an acute lung injury pattern at CT but showing diffuse alveolar damage at surgical biopsy. (a) Frontal chest radiograph at presentation shows faint bilateral perihilar poorly defined bronchovascular bundles best seen involving the left hilum. (b, c) Axial unenhanced CT images through the (b) mid and (c) lower lungs obtained 2 days after presentation show multifocal bilateral ground-glass opacity and consolidation, without a clear zonal predilection. (d) Frontal chest radiograph obtained 6 days after presentation, following the development of hypoxic respiratory failure, shows worsening bilateral opacities. (e) Final chest radiograph 20 days following presentation shows that the bilateral lung opacities have improved significantly, but residual abnormalities remain. Credit: Radiological Society of North America

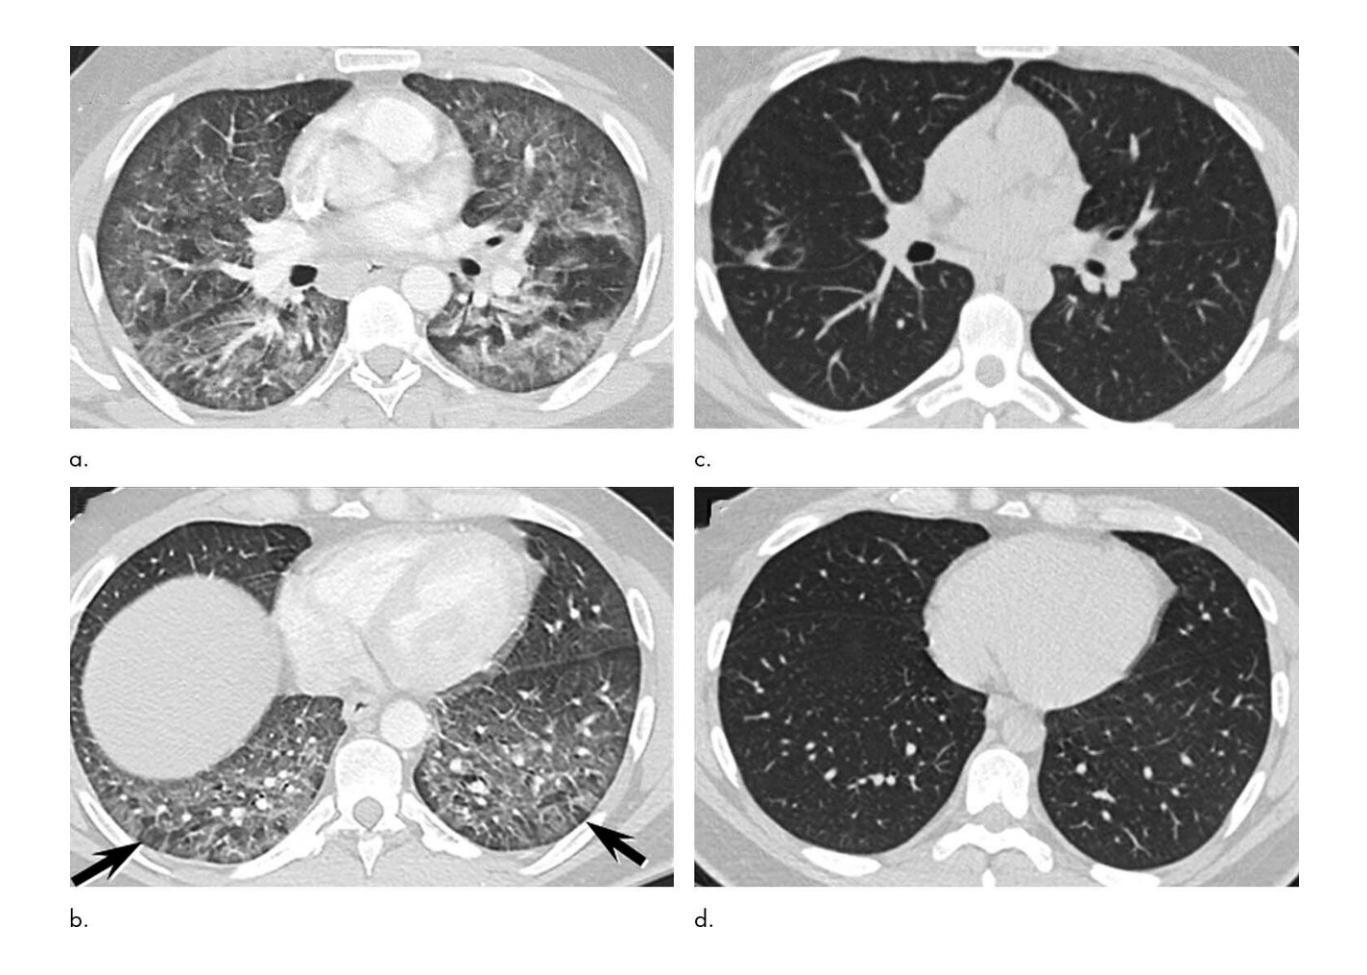
Images in a 39-year-old man with respiratory failure hospitalized for 10 days with an electronic cigarette or vaping product use-associated lung injury manifesting as an acute lung injury pattern at CT with some CT features suggesting a hypersensitivity pattern. (a, b) Axial enhanced CT images through the (a) mid and (b) lower lungs at presentation show multifocal areas of ground-glass opacity with prominent lobular low attenuation in the bases (arrows) suggesting small airway obstruction in addition to the ground-glass opacity. (c, d) Axial unenhanced CT images through the (c) mid and (d) lower lungs obtained 64 days after presentation show complete clearing of lung parenchymal abnormalities. Right middle lobe opacity (c) reflects site of surgical lung biopsy, which showed acute lung injury with organization, but no granulomas or other features typical of hypersensitivity pneumonitis. Credit: Radiological Society of North America
