Radiologists detect injury patterns of intimate partner violence

November 27 2017

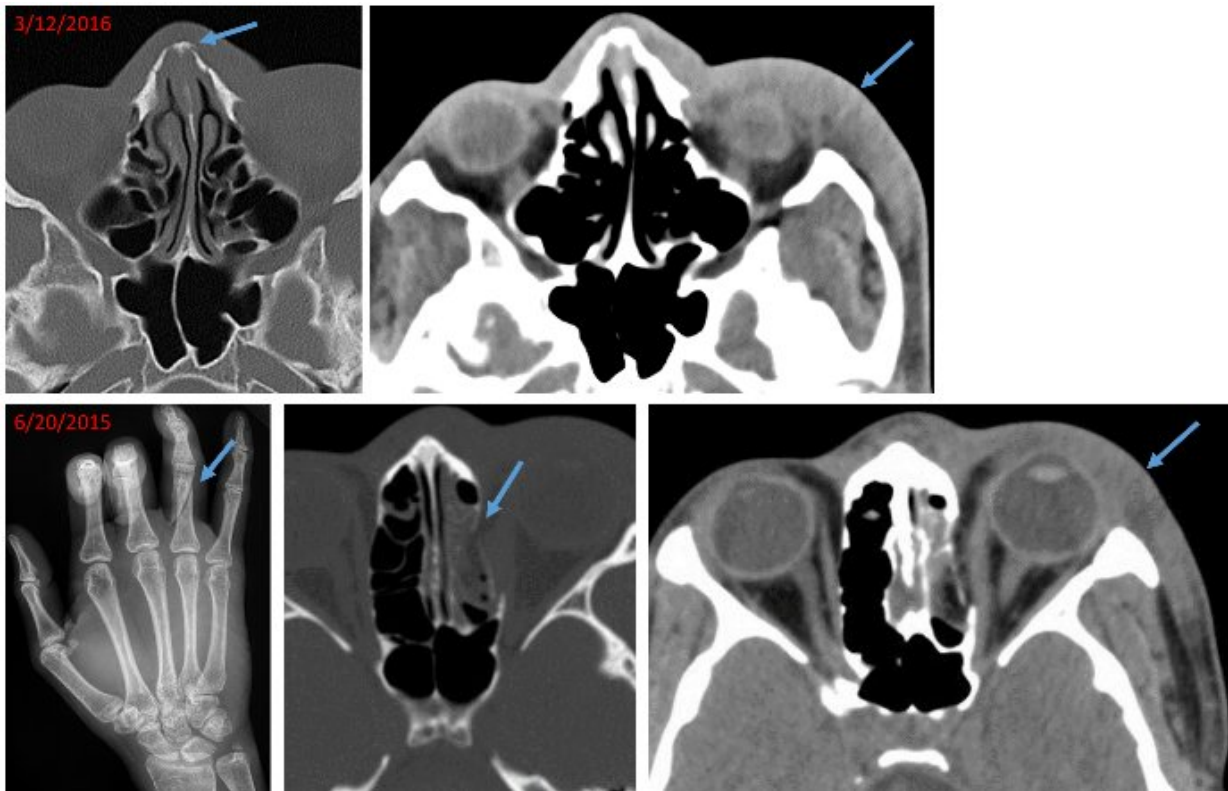
Radiology images from a 21-year-old woman who presented with a chronic nasal bone fracture and soft tissue swelling of the left lateral face. Review of electronic medical records revealed that nine months ago, the patient had suffered a finger fracture, left medial orbital wall fracture and similar soft tissue swelling on the left side of the face. Traumatic findings separated in time suggest recurrent violence. Credit: Elizabeth George, Brigham and Women's Hospital

The case that inspired the principal investigator Bharti Khurana, MD, involved a young woman who presented to the Emergency Department with an acute nasal bone fracture superimposed on an old healed fracture. While going through prior studies of the patient on the hospital's picture archiving and communication system, or PACS, she came across a recent wrist fracture. This pattern of recurrent injury made her raise the suspicion for intimate partner violence, a finding the referring physician initially had not suspected.

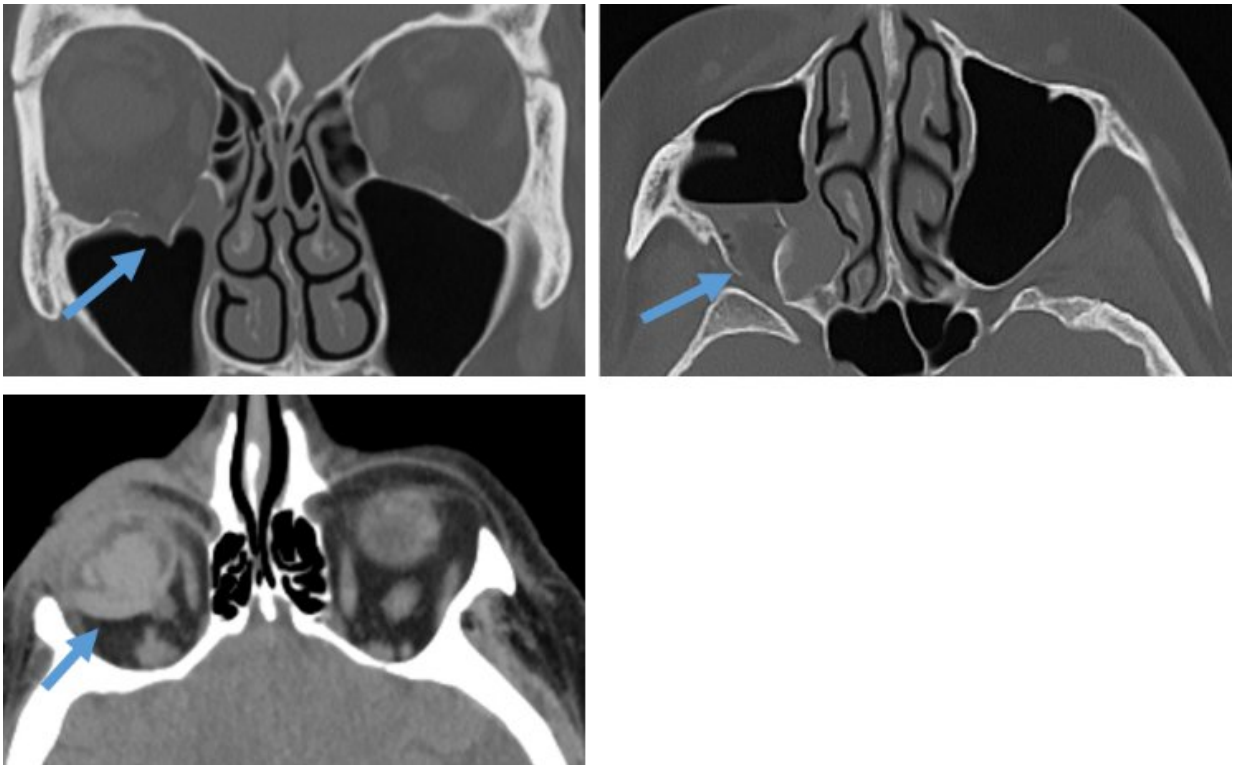
Radiology images from a 76-year-old female who presented with right sided vision loss after being punched by her husband. The patient was found to have right orbital floor and right posterolateral maxillary wall fracture as well as a right orbital hematoma. Credit: Elizabeth George, Brigham and Women's Hospital
