# Lung injuries from vaping have characteristic patterns on CT

August 27 2020

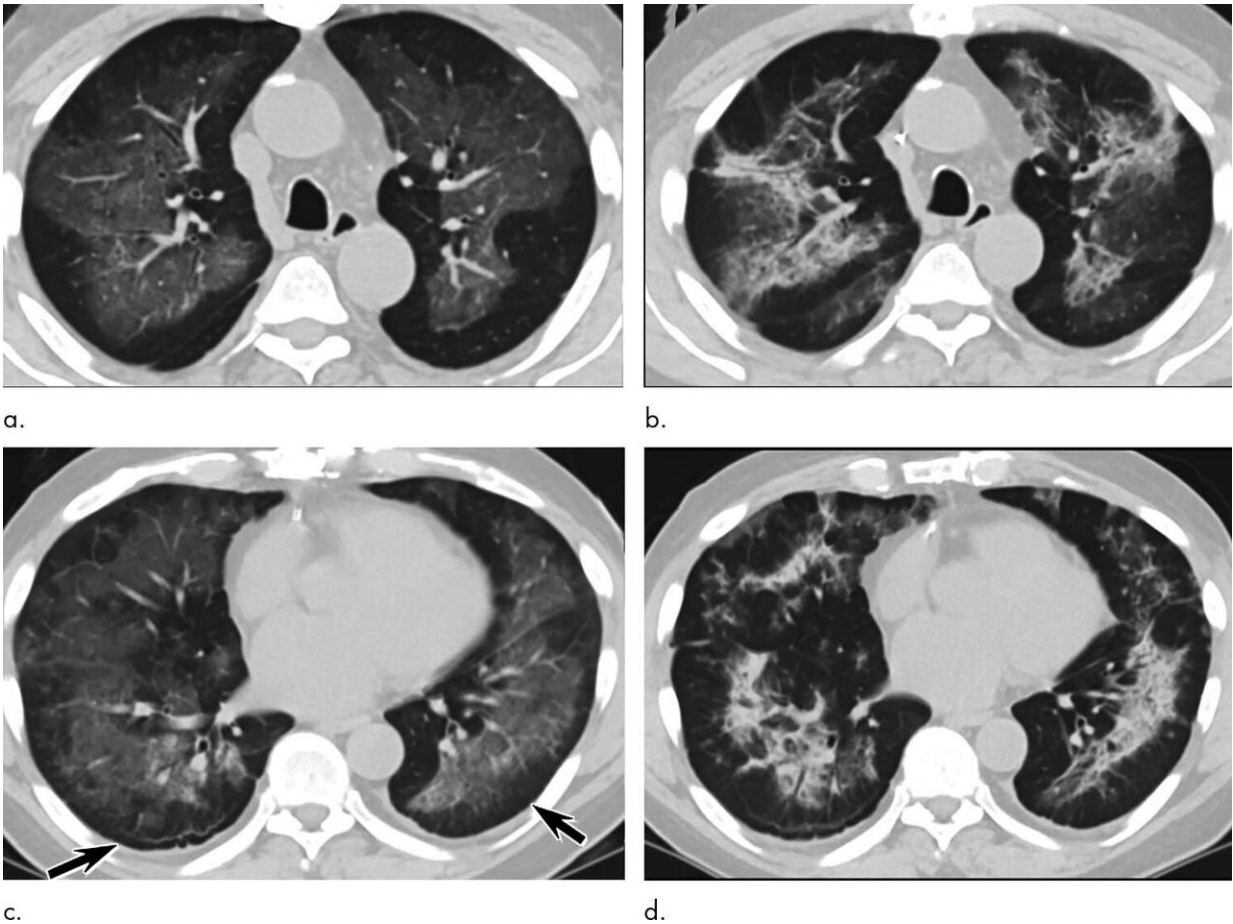
Electronic cigarette or vaping product use-associated lung injury in a 51-year-old man manifesting as an acute lung injury pattern at CT with subsequent organization. (a, c) Axial unenhanced CT images at presentation through (a) mid and (c) lower lungs show ground-glass opacity with subpleural sparing (arrows); this distribution was present in 45% of chest CT studies at presentation in our cohort (11). (b, d) Axial unenhanced CT images obtained 6 days later show

ground-glass opacity has transitioned to consolidation and mild architectural distortion, consistent with developing organization. The patient was initially treated with antibiotics followed by corticosteroid therapy, with slow clinical improvement. Credit: Radiological Society of North America

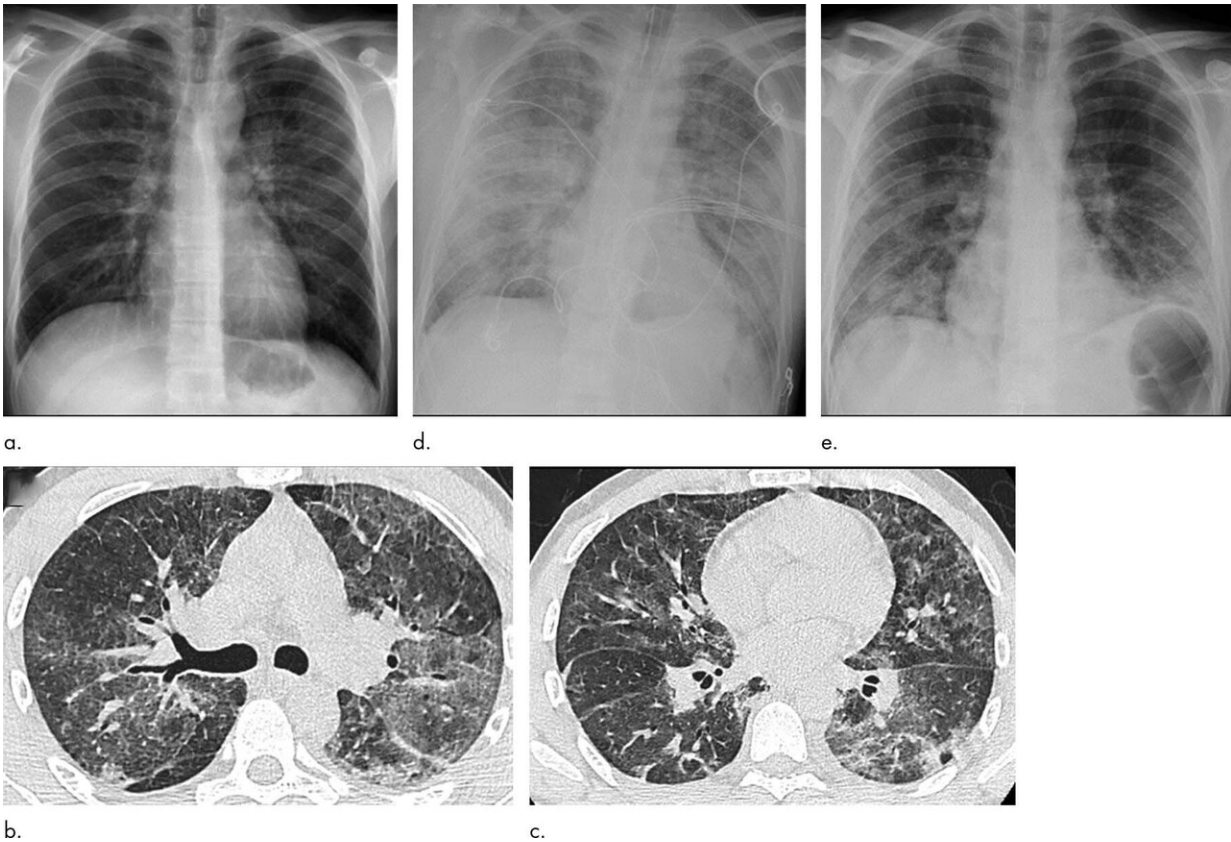
Electronic cigarette or vaping product use-associated lung injury in a 27-year-old man manifesting as an acute lung injury pattern at CT but showing diffuse alveolar damage at surgical biopsy. (a) Frontal chest radiograph at presentation shows faint bilateral perihilar poorly defined bronchovascular bundles best seen involving the left hilum. (b, c) Axial unenhanced CT images through the (b) mid and (c) lower lungs obtained 2 days after presentation show multifocal bilateral ground-glass opacity and consolidation, without a clear zonal predilection. (d) Frontal chest radiograph obtained 6 days after presentation, following the development of hypoxic respiratory failure, shows worsening bilateral opacities. (e) Final chest radiograph 20 days following presentation shows that the bilateral lung opacities have improved significantly, but residual abnormalities remain. Credit: Radiological Society of North America

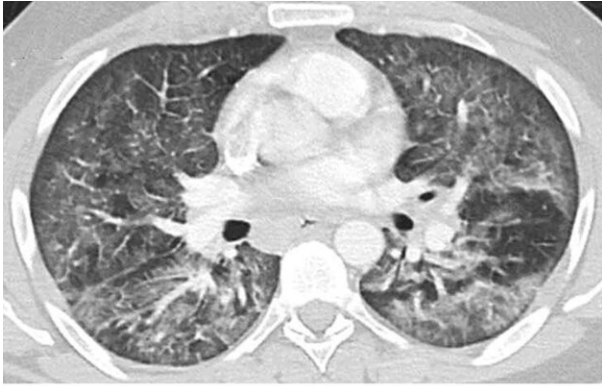
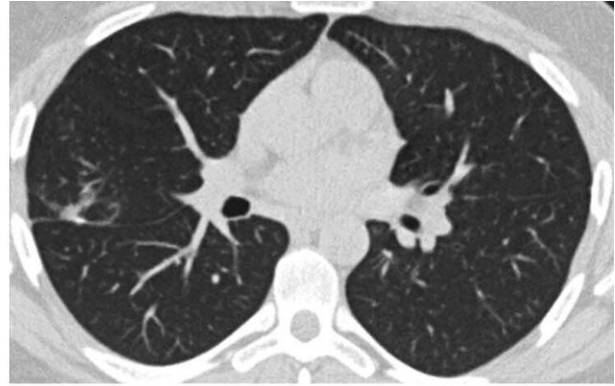
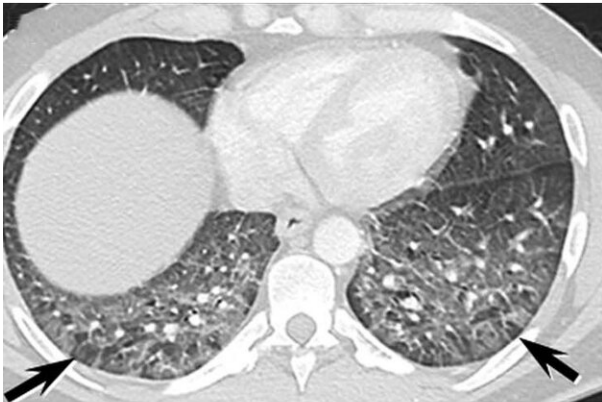
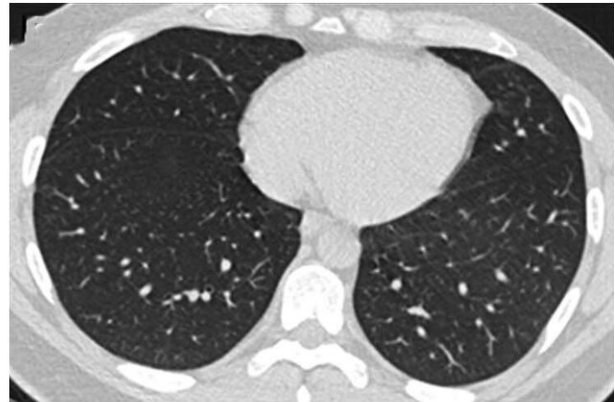
Images in a 39-year-old man with respiratory failure hospitalized for 10 days with an electronic cigarette or vaping product use-associated lung injury manifesting as an acute lung injury pattern at CT with some CT features suggesting a hypersensitivity pattern. (a, b) Axial enhanced CT images through the (a) mid and (b) lower lungs at presentation show multifocal areas of ground-glass opacity with prominent lobular low attenuation in the bases (arrows) suggesting small airway obstruction in addition to the ground-glass opacity. (c, d) Axial unenhanced CT images through the (c) mid and (d) lower lungs obtained 64 days after presentation show complete clearing of lung parenchymal abnormalities. Right middle lobe opacity (c) reflects site of surgical lung biopsy, which showed acute lung injury with organization, but no granulomas or other features typical of hypersensitivity pneumonitis. Credit: Radiological Society of North America
