Study looks at Achilles' heel of insulin pump technology

Objective: To investigate skin changes at continuous subcutaneous insulin infusion (CSII) sites in patients with type 1 diabetes using traditional histopathology and novel noninvasive skin imaging with optical coherence tomography (OCT)

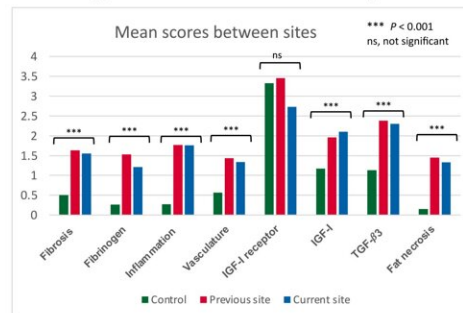
Graphical abstract. Credit: *Diabetes Care* (2023). DOI: 10.2337/dc23-0426

Histology and Immunohistochemistry

The OCT identified increased inflammation and vessel density at insulin pump sites.

Eosinophilic inflammation was significantly more common at the current and previous sites compared with control ($P < 0.01$).

Using a non-invasive technique, called [optical coherence tomography](#), or OCT, researchers were able to monitor [blood flow](#) and inflammation around the sites. Greater blood flow would result in quicker insulin absorption. Skin biopsies were taken at the pump infusion sites.
